**RAILWAY INVESTIGATION REPORT  
R14E0081**

**MAIN-TRACK DERAILMENT**

**CANADIAN NATIONAL  
FREIGHT TRAIN A41851-11  
MILE 202.3, SLAVE LAKE SUBDIVISION  
FAUST, ALBERTA  
11 JUNE 2014**

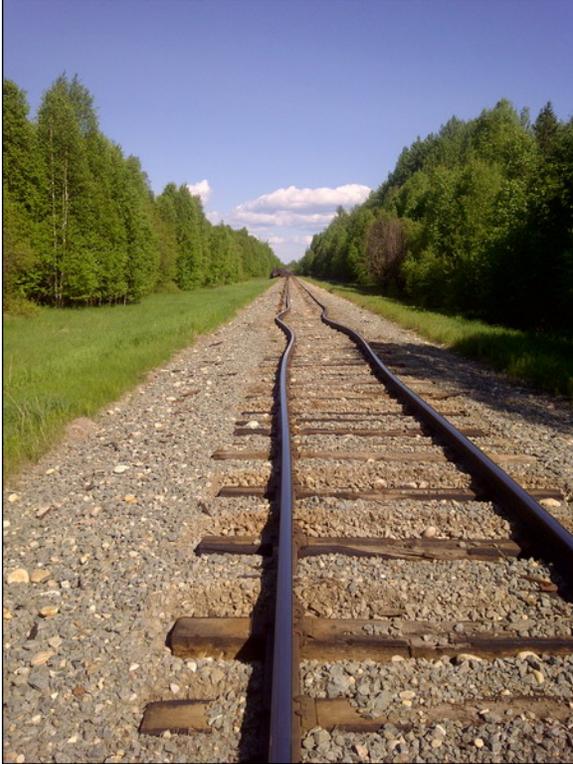
At the west end of the derailment site, the track had buckled and shifted laterally to the north by up to 12 inches. The track buckle began approximately 200 feet east of the switch located at Mile 202.53 and extended eastward in an “S” shape (Photo 1 and Photo 2). Near the middle of the track buckle, there was a diagonal wheel flange mark on the head of the north rail, extending eastward from the gauge side. On the field side of the north rail, there were impact marks on the spikes, tie plates, and ties. There were corresponding impact marks on the ties on the gauge side of the south rail. The point of derailment was determined to be Mile 202.3.

Photo 1. Eastward view showing the track buckle (north is to the left)

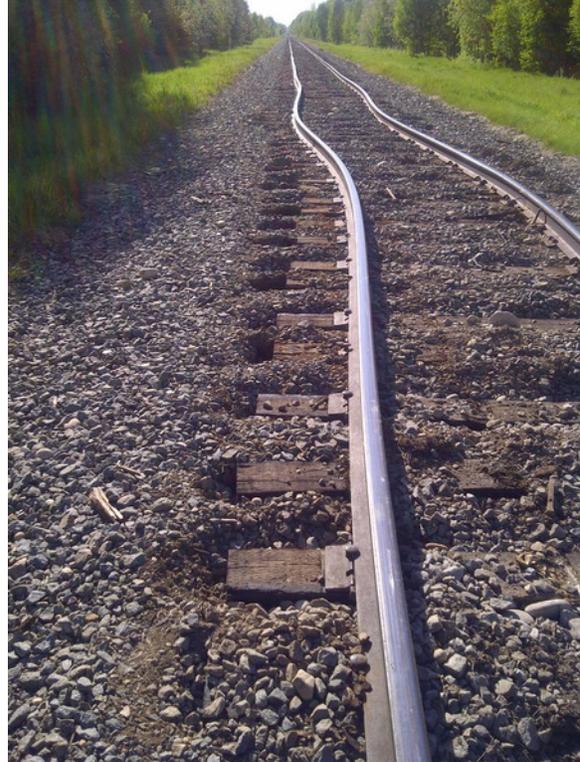
Photo 2. Westward view showing track shifted in the ballast, leaving gaps of up to 12 inches between the end of the tie and the ballast shoulder

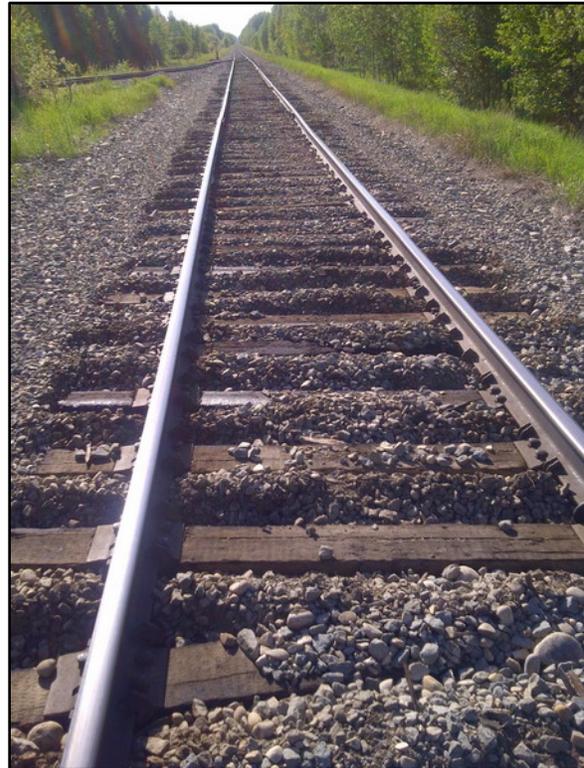
Track damage consisting of broken tie ends and damaged fasteners extended for approximately 1200 feet. Leading up to the track buckle, rail anchors had moved away from the ties, and the ties were plowing and skewed in several locations (Photo 3).

Photo 3. Ties plowing and skewed west of the derailment site

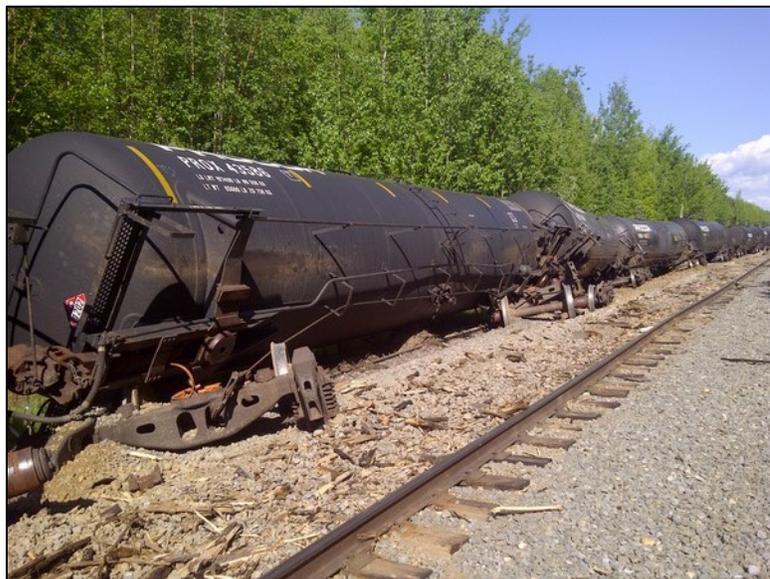
All 20 cars derailed to the north side of the track. Cars 107 to 120 derailed upright, cars 121 and 122 were leaning, and the last 4 cars (123 to 126) were on their sides (Photo 4). Car 107 was a load of wood products. Cars 108 and 109 were empty hopper cars, and the remaining 17 derailed cars were residue tank cars (DOT 111A100W1) that had last carried diesel fuel (UN 1202).

Photo 4. Tank cars derailed on their sides

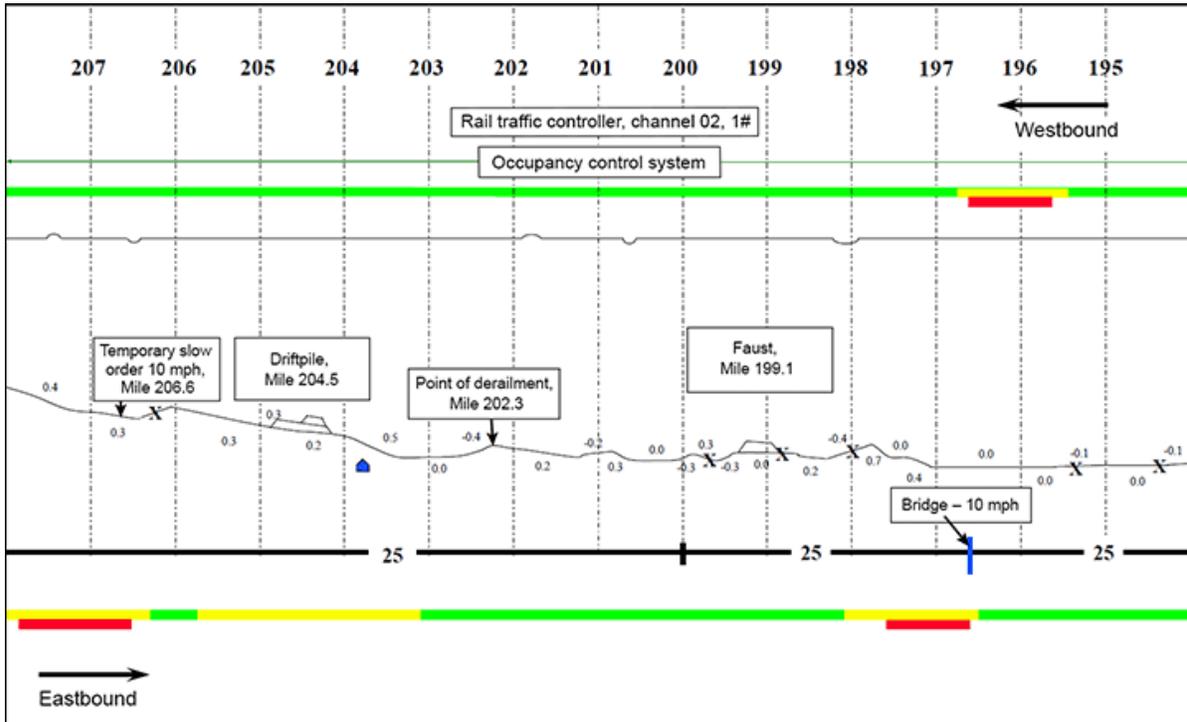
The track in the area of the derailment is tangent single main track, oriented east-west. In the direction of travel (west to east), between Mile 206.0 and 203.5, there is a descending grade varying between 0.2% and 0.5%. The track then levels off for about 1 mile (Mile 203.5 to Mile 202.5), and then transitions into a short ascending 0.4% grade (Figure 3).

Figure 3. Track profile (Source: Canadian National, with TSB annotations) (Note: Colour references, green for throttle manipulation, yellow for dynamic braking, and red for automatic brake are based on an optimum train run.)

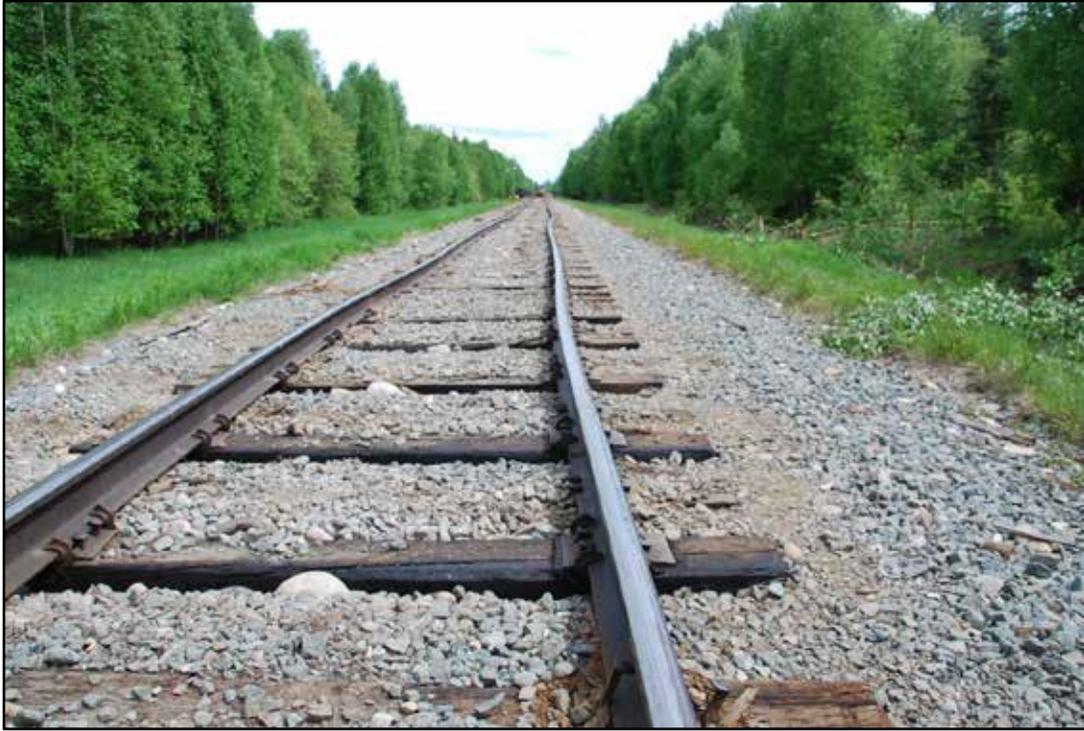
In the vicinity of the derailment site, the rail was a mix of 100-pound and 115-pound continuous welded rail (CWR) and jointed rail manufactured by Sydney Steel Corporation (SYSCO) in the 1970s and 1980s. The rail was laid on 11-inch, double-shouldered tie plates, with 3 spikes per plate. Tie condition was fair. Some new ties with 14-inch double-shoulder tie plates and 4 spikes per plate had recently been installed to break up a number of defective tie clusters. The rail anchor pattern was irregular. Ballast was a mix of crushed gravel and pit run gravel, with some crushed stone on the surface. The cribs were full, and the shoulders were a minimum of 12 inches wide and were in fair condition (Photo 5). The subgrade in the vicinity of the derailment site is peat bog.<sup>11</sup>

Photo 5. Ballast and rail anchoring conditions leading up to the derailment site

1. The derailment occurred when the track shifted laterally under the passing train.
2. The track buckled as a result of the irregular rail anchoring pattern, a build-up of compressive stress in the rail, and a relatively unstable peat bog subgrade, which was unable to restrain the longitudinal forces generated by the train descending the grade.
3. High compressive stress had likely accumulated in the track structure as a result of repeated exposure to longitudinal forces from previous trains that had used dynamic braking at this location.
4. The condition of the track could not handle the traffic levels that had increased significantly on this corridor since 2013, in advance of the recommended infrastructure improvements.
